Manhole Inspection Summary

Manhole # S47EE_022MH

Insp Date: **7/17/08 11:56 AM**

Location Address: **Patterson Park**

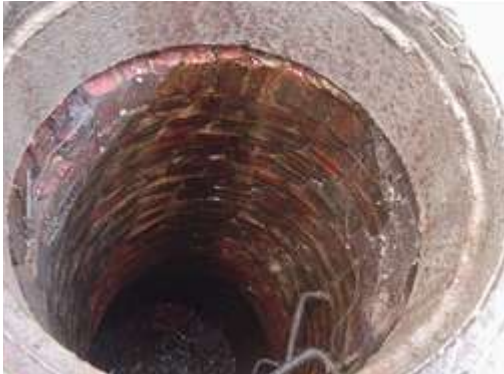
Defect 2

Frame Offset: **1** (in.) Condition: ☐ Sound ☐ Cracked ☒ **Leaks**

Frame leaks

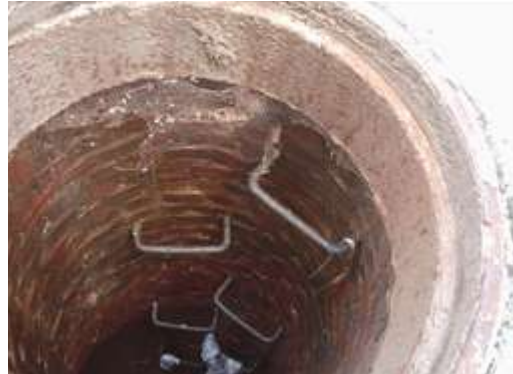
Defect 1

Infiltration: ☐ None ☐ Joint ☐ Cracks ☒ **Mortar** ☐ Roots ☐ Wall

Infiltration: ☐ None ☐ Joint ☐ Cracks ☐ Mortar ☐ Roots ☒ **Wall**

Infiltration

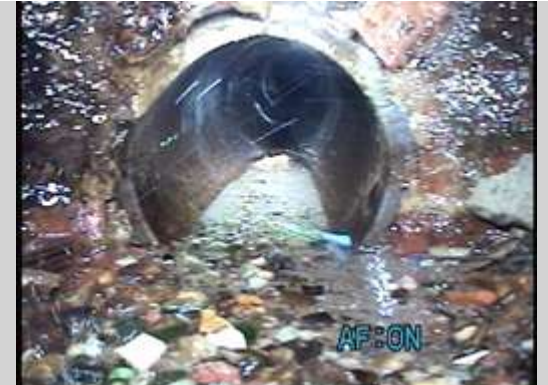
12 O'Clock Outflow

8 in. Circular Gravity Sewer
Pipe Out @ 12 O'Clock
